**EXPERIMENTAL CULVERT PIPE, STH 80  
JUNEAU AND WOOD COUNTIES, WISCONSIN**

**FINAL REPORT**

**NOVEMBER 2003**

**FEDERAL EXPERIMENTAL PROJECT # WI 80-02,03,04**

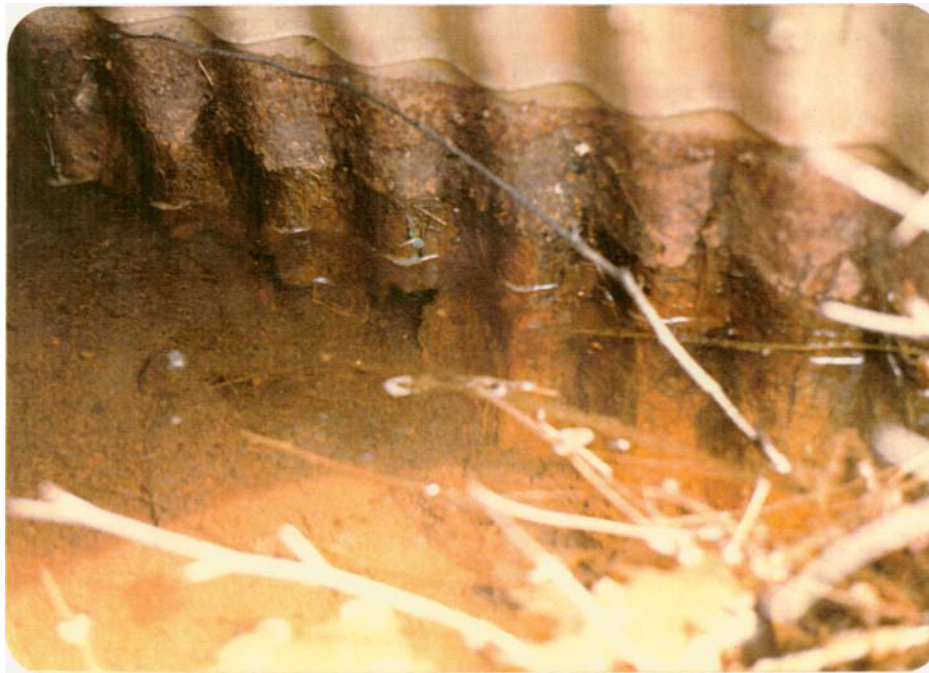
Station 713+36. Original 12 gage galvanized steel pipe. Note holes in side of invert. Corrosion mostly scale. Tag 1941. 1975

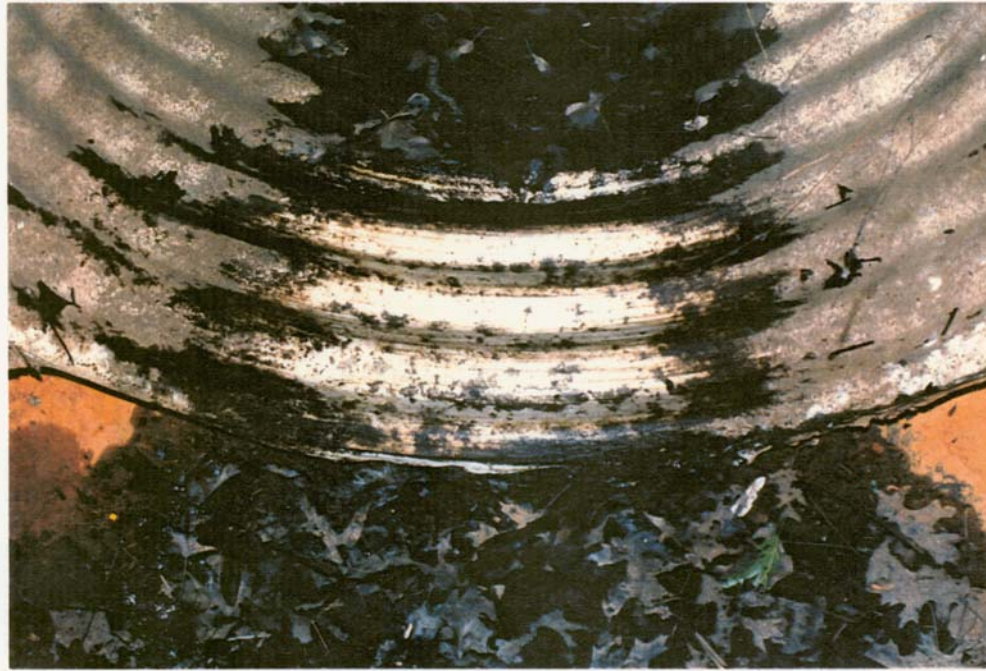
Station 713+36. Some pitting of the cladding of the aluminum pipe. Apparently a reaction with organic-rich soil. Outlet. 1986

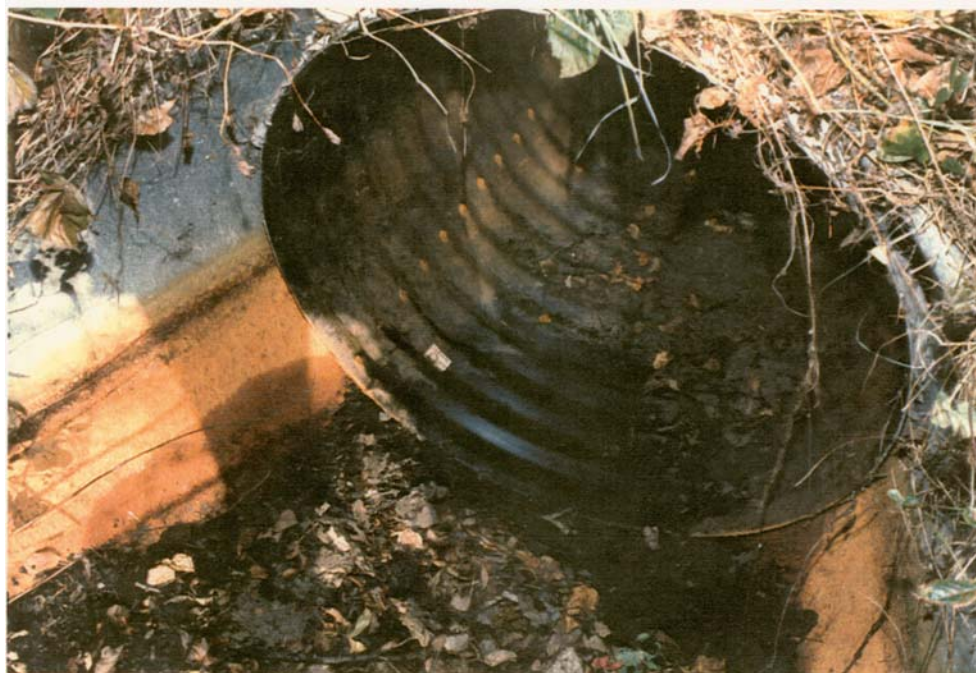
Station 713+36. Oxidation of uncoated rivet heads and section ends of polymeric coated pipe. Note corrosion of endwalls. Inlet. 1987

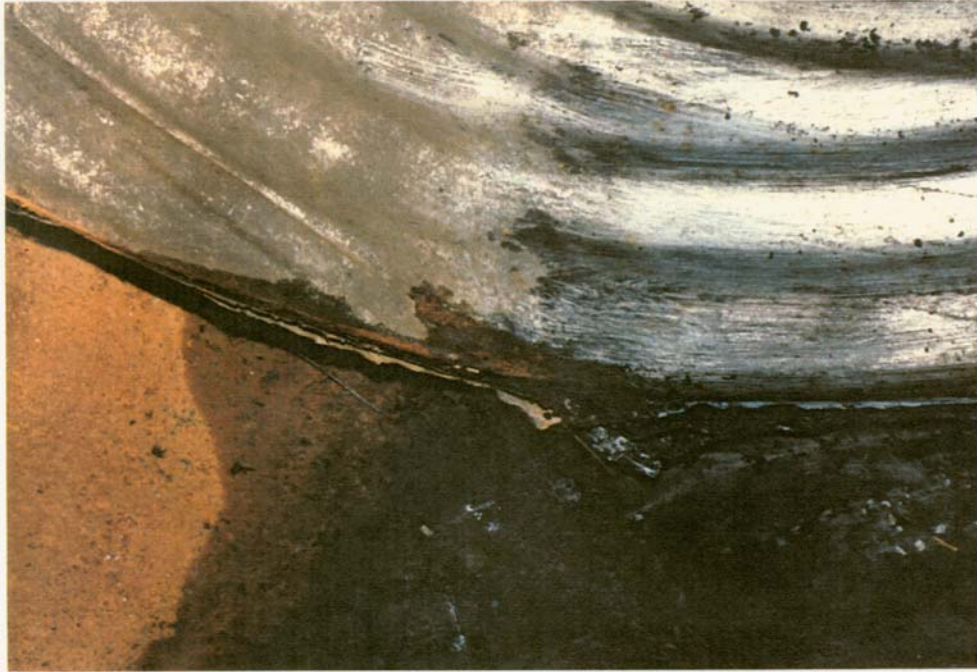
Station 713+36. Some oxidation of the weld area on the lock seam of the aluminized steel pipe. This did not change in later years. Outlet. 1987

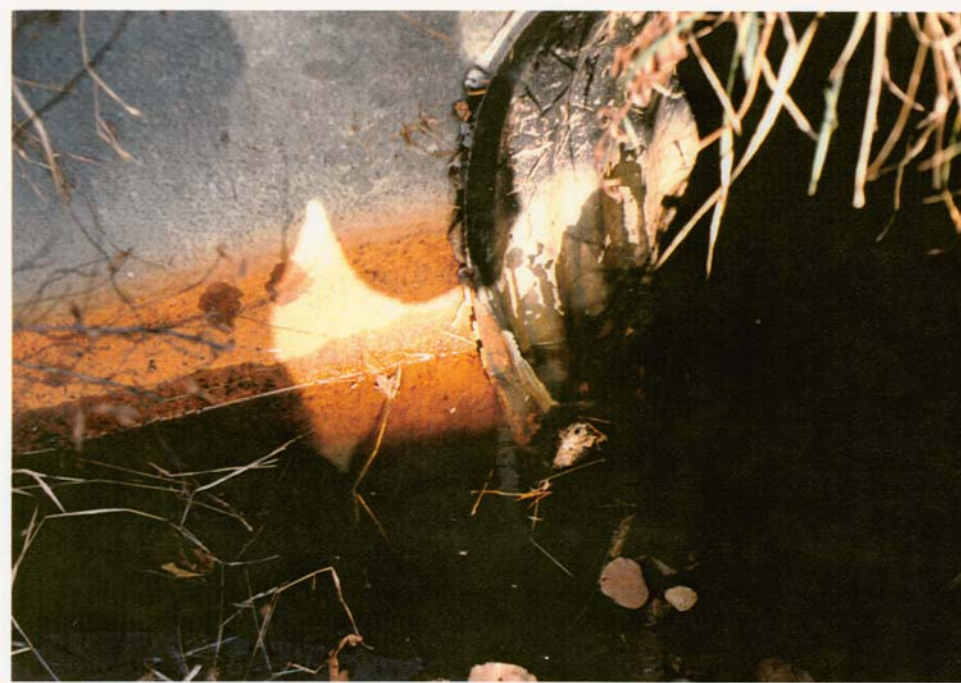
Station 713+36. Some separation of polymeric coating from steel at inlet end of pipe. 1992

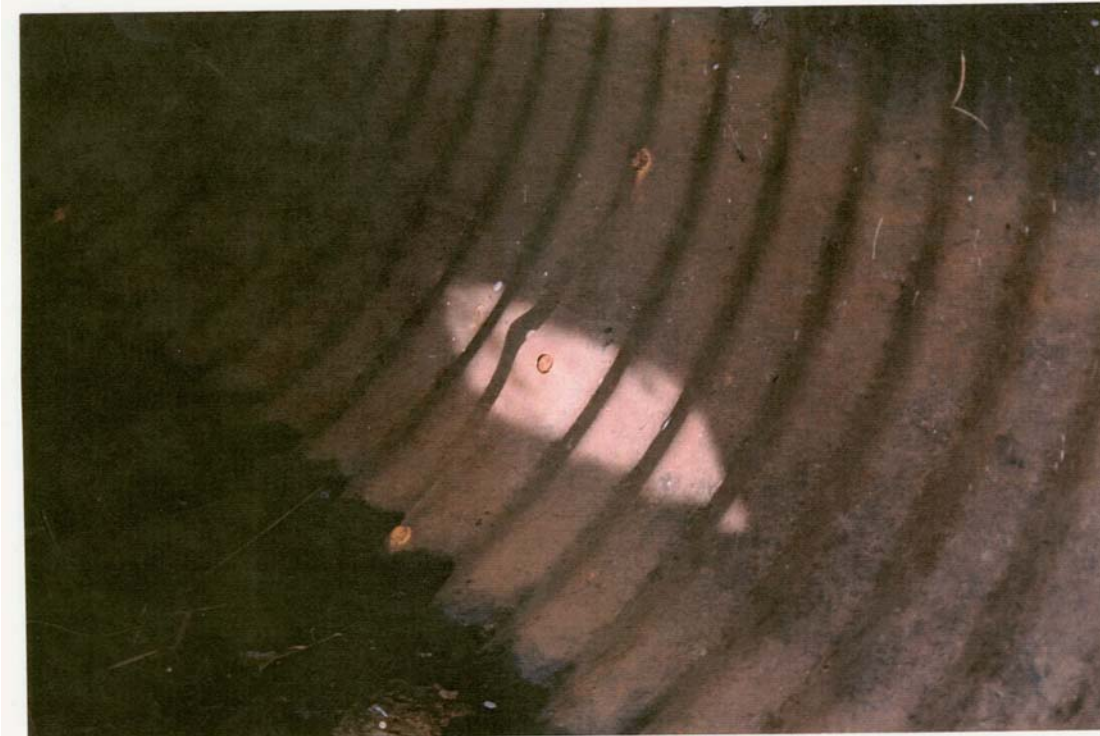
Station 713+36. Some separation of polymeric coating from steel at uncoated rivet heads and section heads. 1994

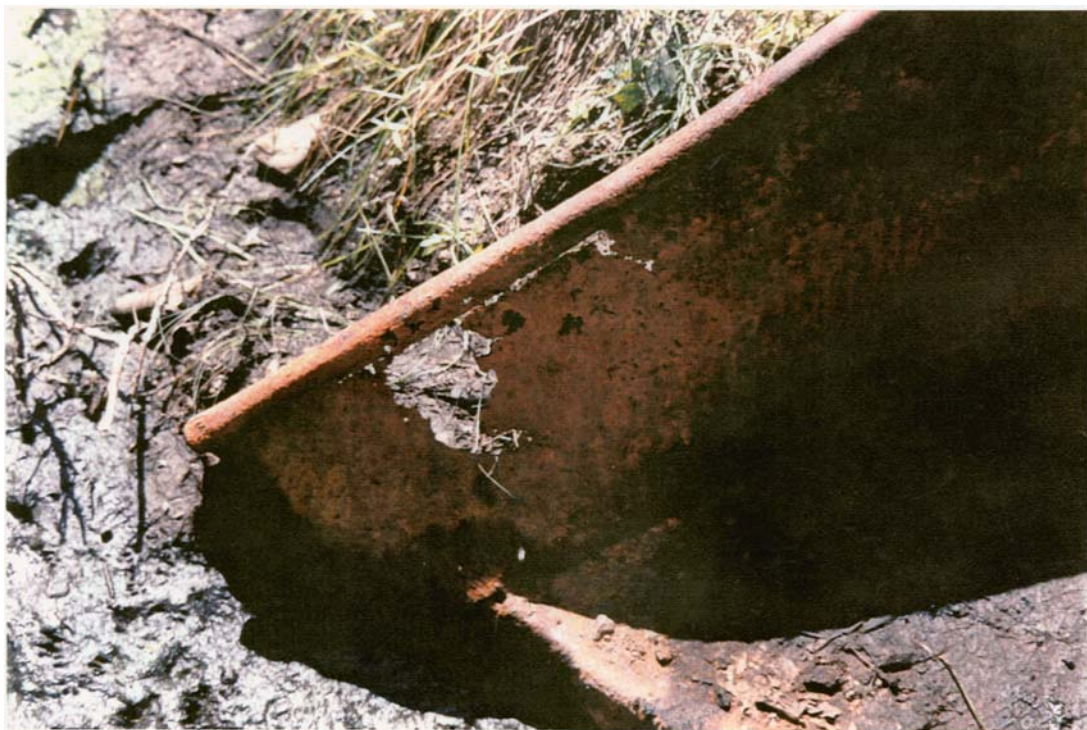
Station 713+36. Perforation of galvanized steel apron endwall attached to aluminized steel pipe. 1994

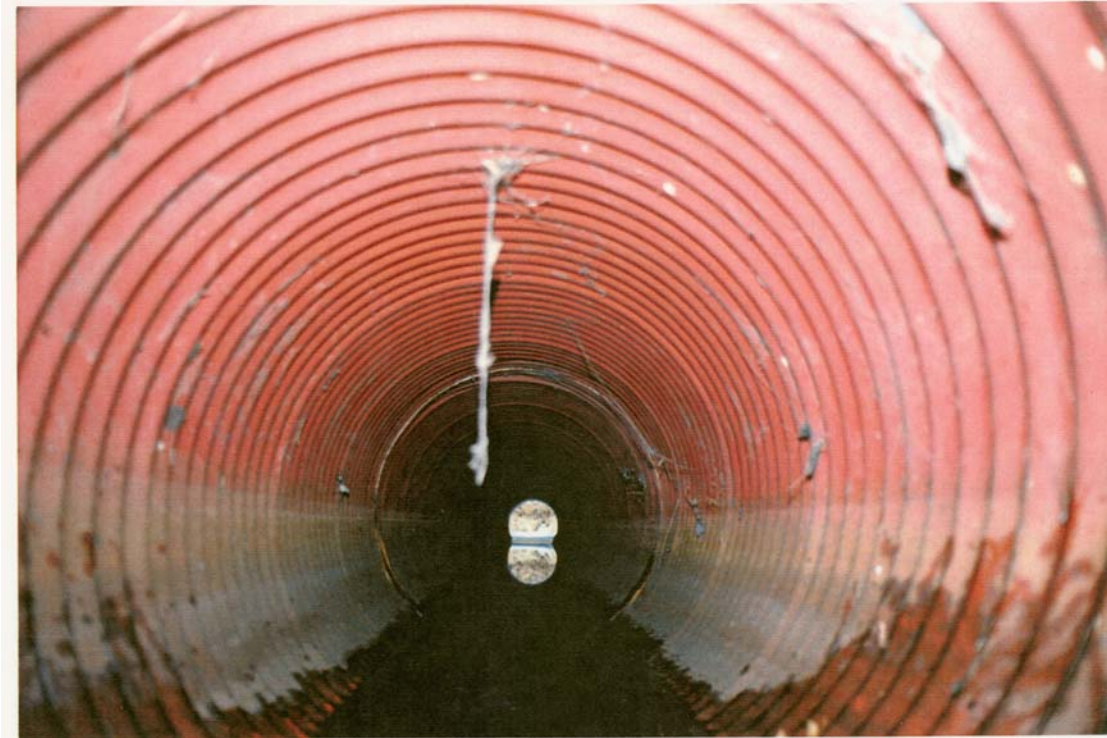
Station 713+36. Loss of epoxy coating at first joint of epoxy bonded pipe and advanced corrosion of steel. This part of pipe commonly under water. Inlet. 1994

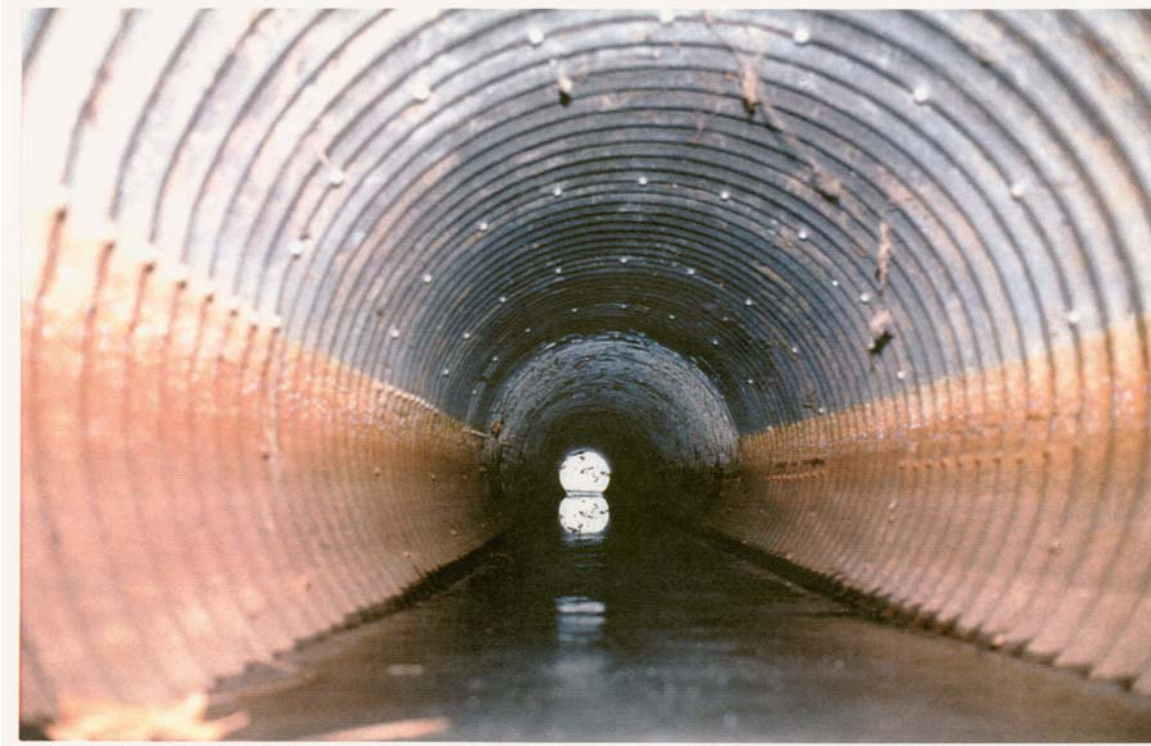
Station 713+36. View through polymeric coated pipe to aluminum pipe. Pipes joined near center of road. White precipitate is on roof of aluminum pipe. Precipitate greatest under pavement, with little precipitate under shoulder and back slope. Precipitate enters through roof of pipe. This condition is commonly an indication of moderate corrosion of the soil side of the pipe at the roof and is apparently related to use of NaCl deicer. Brown coloration on lower part of polymeric coated pipe is stain. 1994

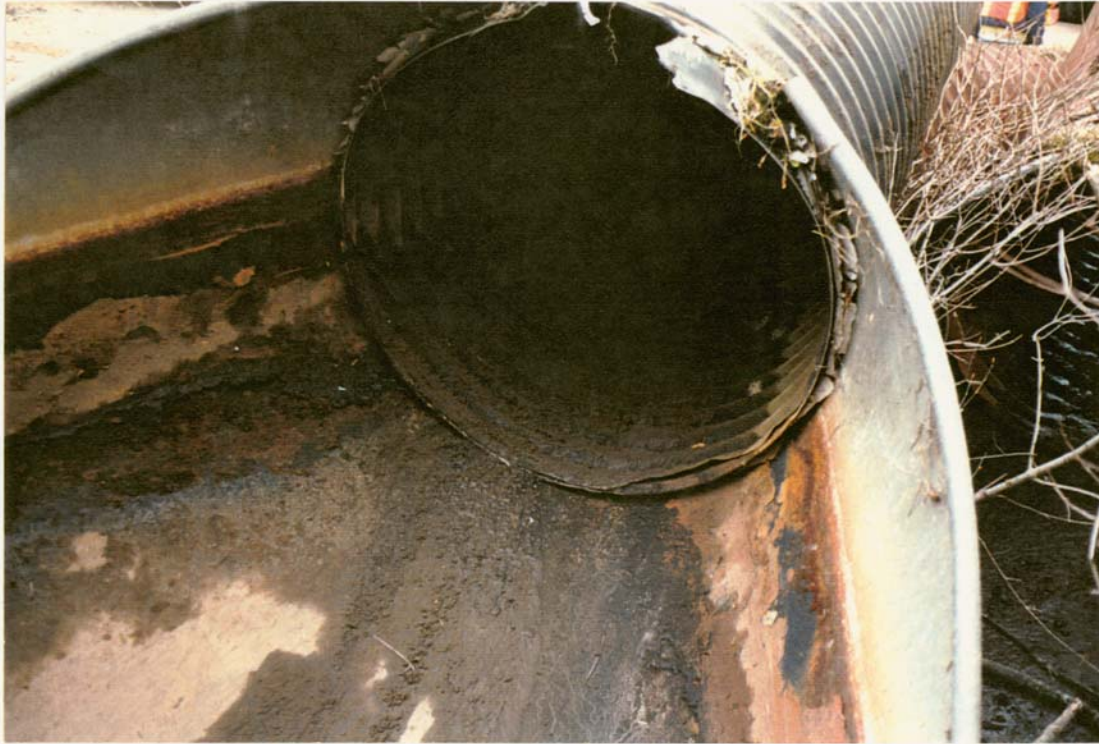
Station 713+36. Pipe removal. This was formerly the inlet end. Note separation of polymeric coating. The ends of the steel sections were not coated.

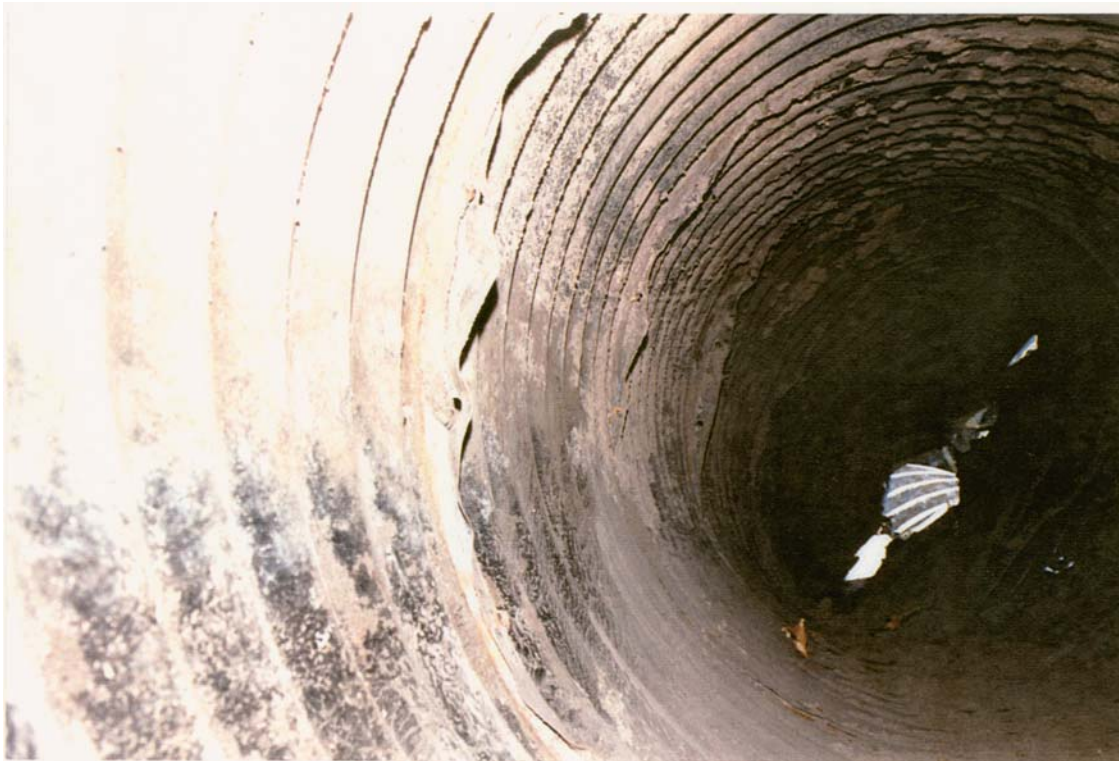
Station 713+36. Invert on side. Note separation at section ends. 1995

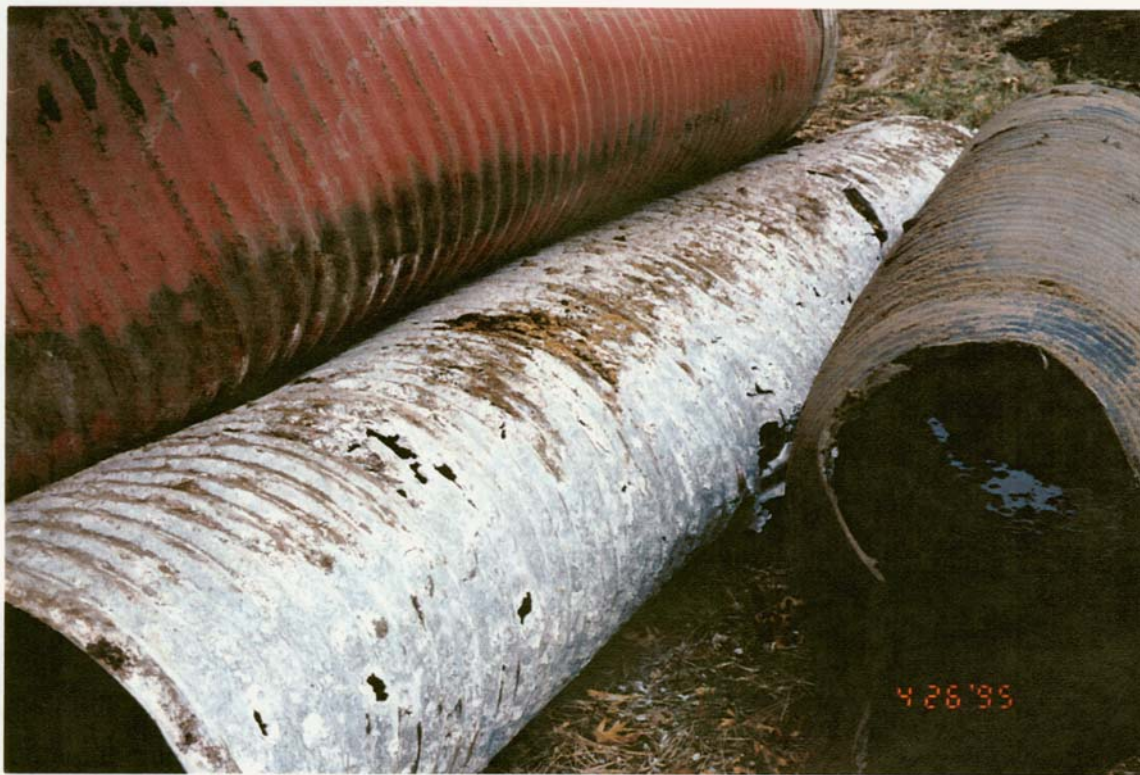
Station 713+36. Perforations and white precipitate on roof of aluminum pipe.

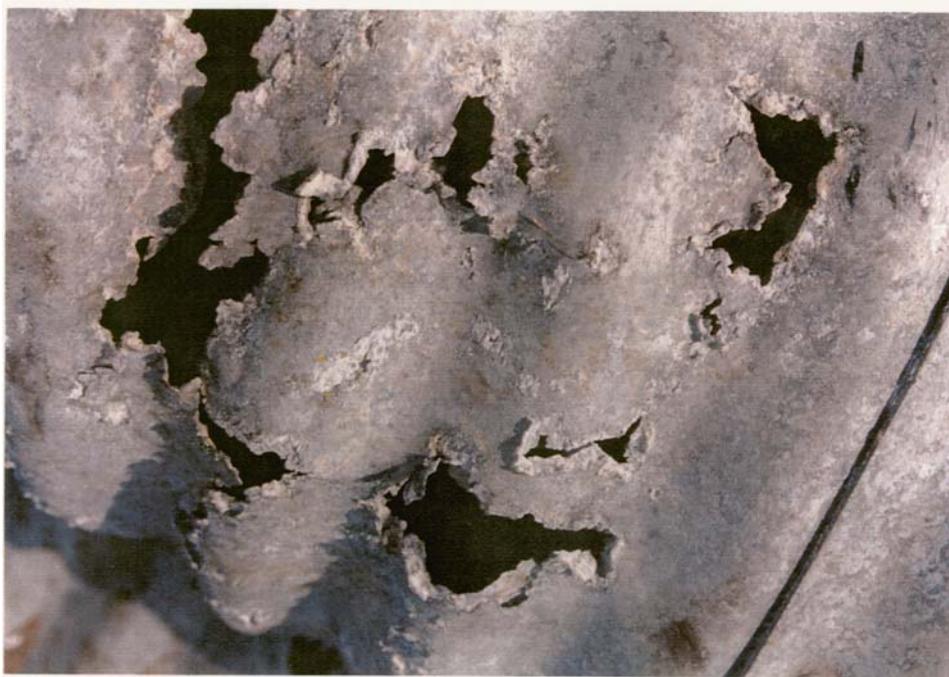
Station 713+36. Close-up of corrosion on roof; aluminum pipe. 1995

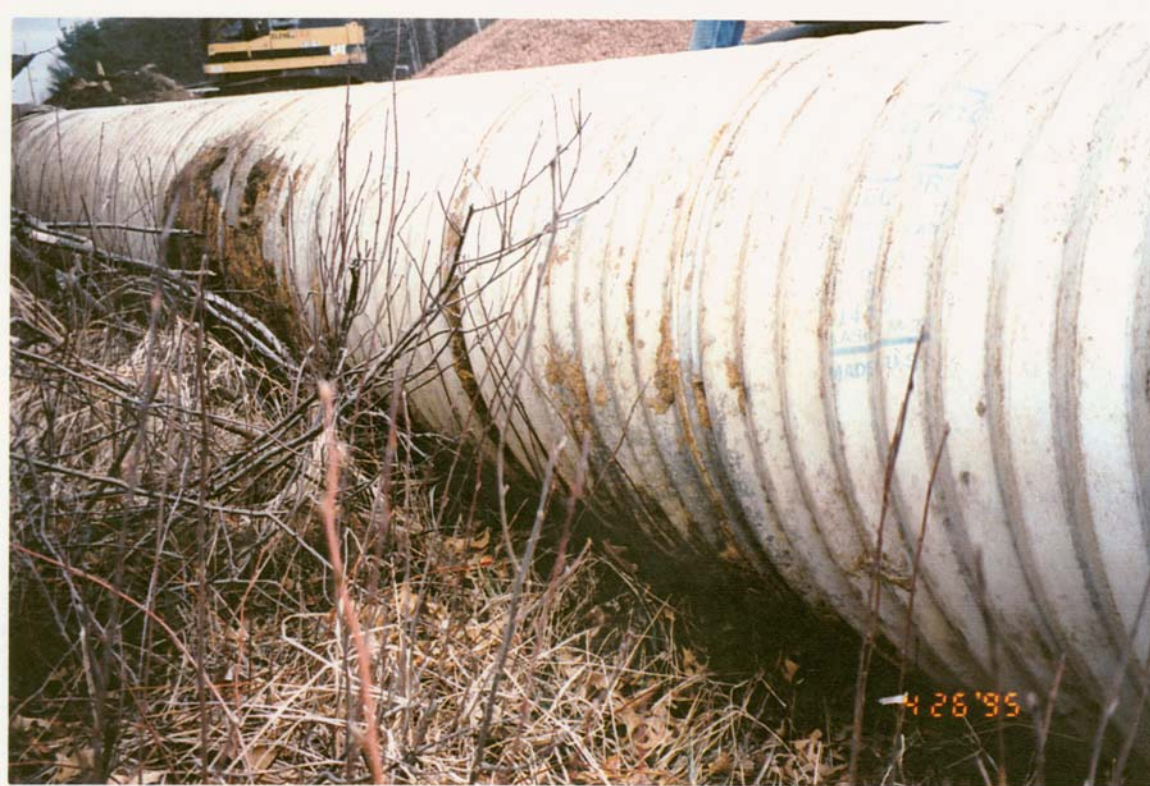
Station 713+36. Aluminized steel. Localized areas of organic-rich fill adhering to pipe.

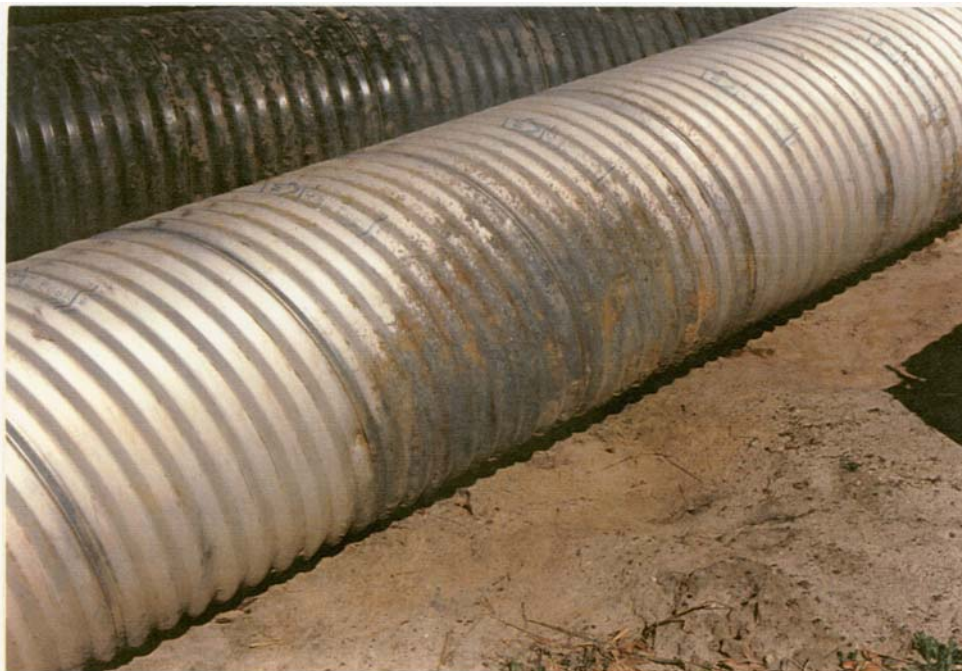
Station 713+36. Beneath organic-rich fill, barrier coating removal with some small 1/8 inch pits through to steel core. 1995

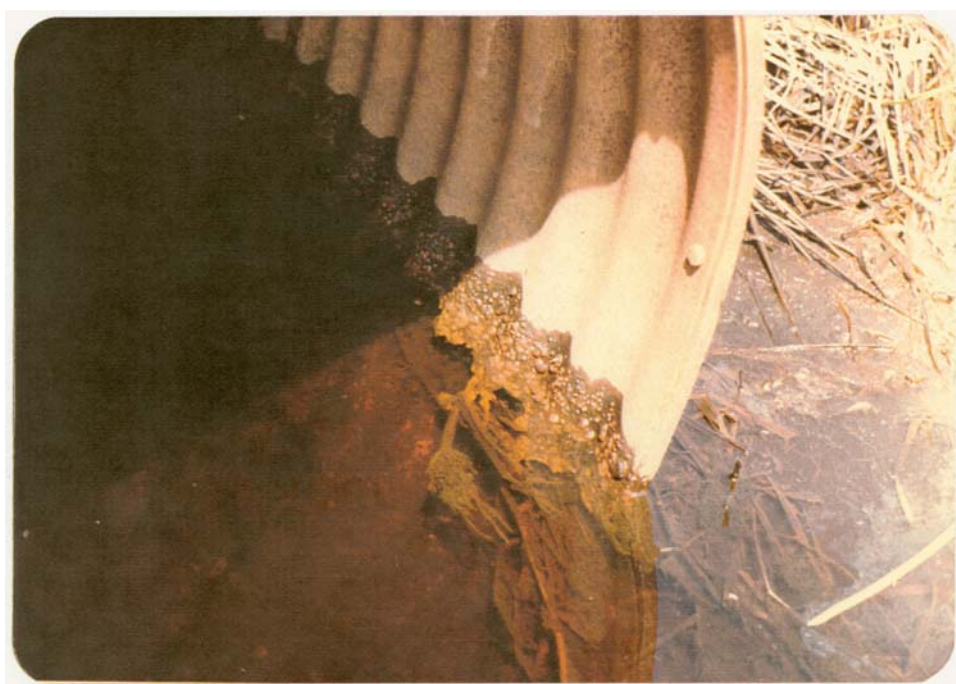
Station 976+40. Original 12 gage galvanized steel pipe. Note nodules along flow line produced by sulfate reducing bacteria. Invert separated from remainder of pipe. 1975

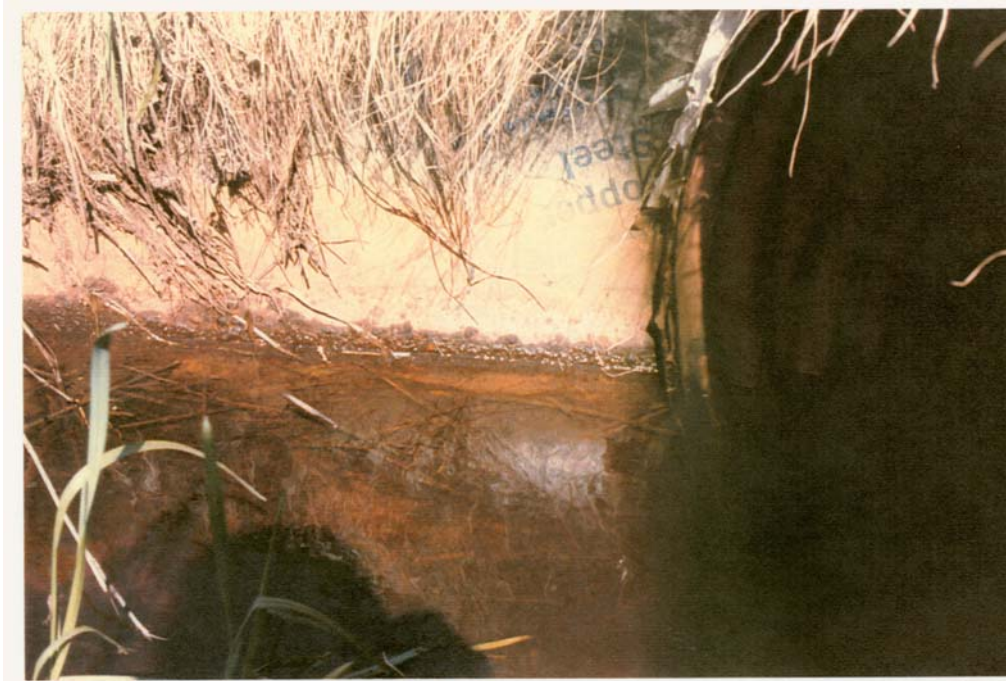
Station 976+40. SRB nodules at water line on galvanized steel apron endwalls. 1985

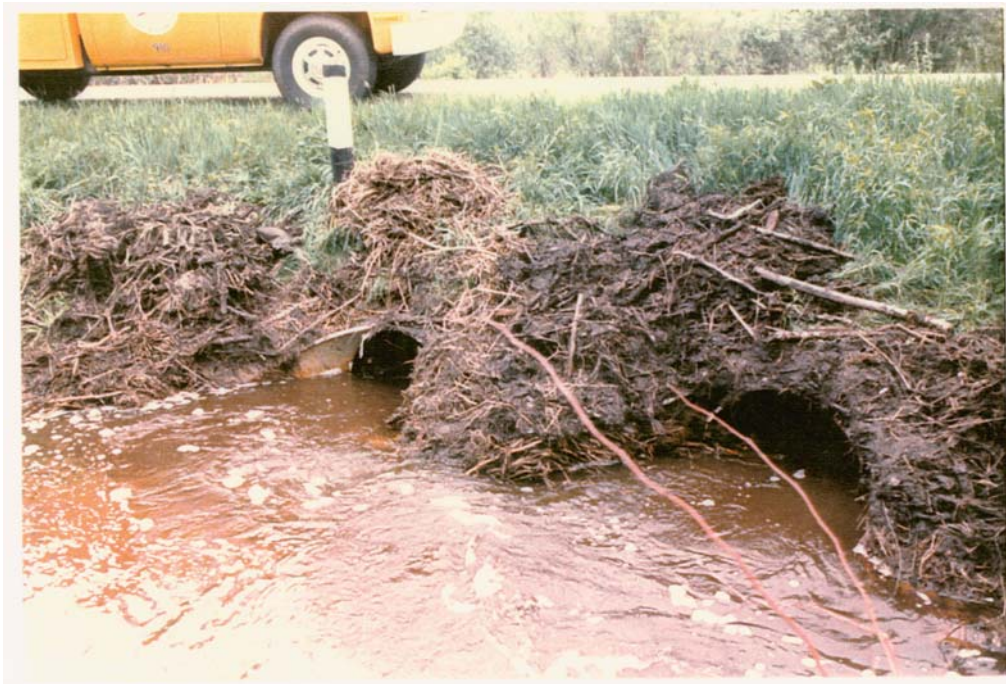
Station 976 + 40. One of recurring beaver dams at inlet, recently removed. Water is commonly too high to permit inspection of pipes. 1987

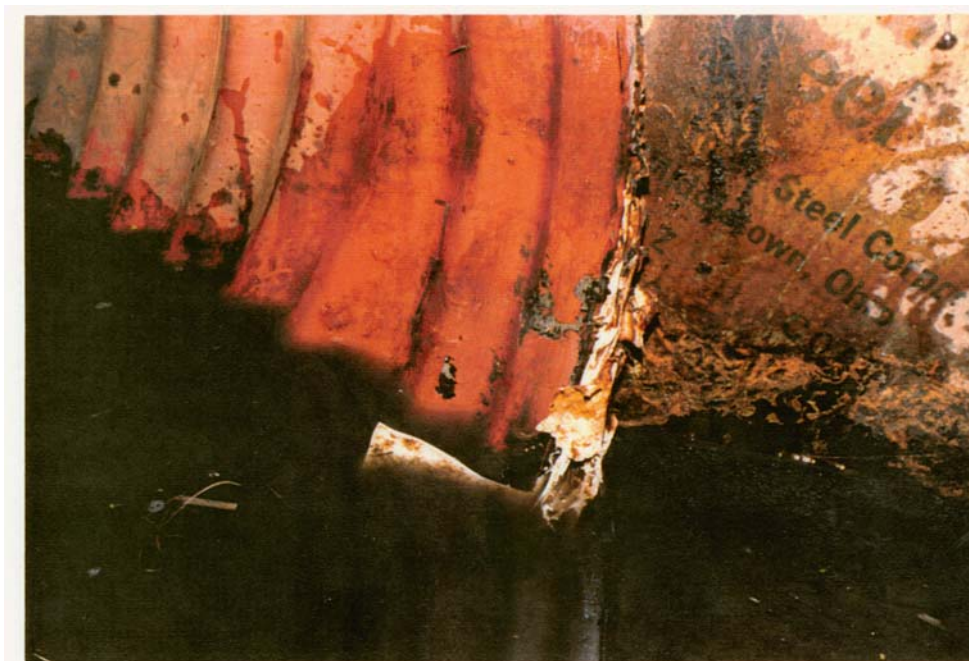
Station 976+40. Epoxy bonded pipe.  
Loss of epoxy at inlet of pipe. Note  
corrosion of apron endwalls, with no  
epoxy coating. 1987

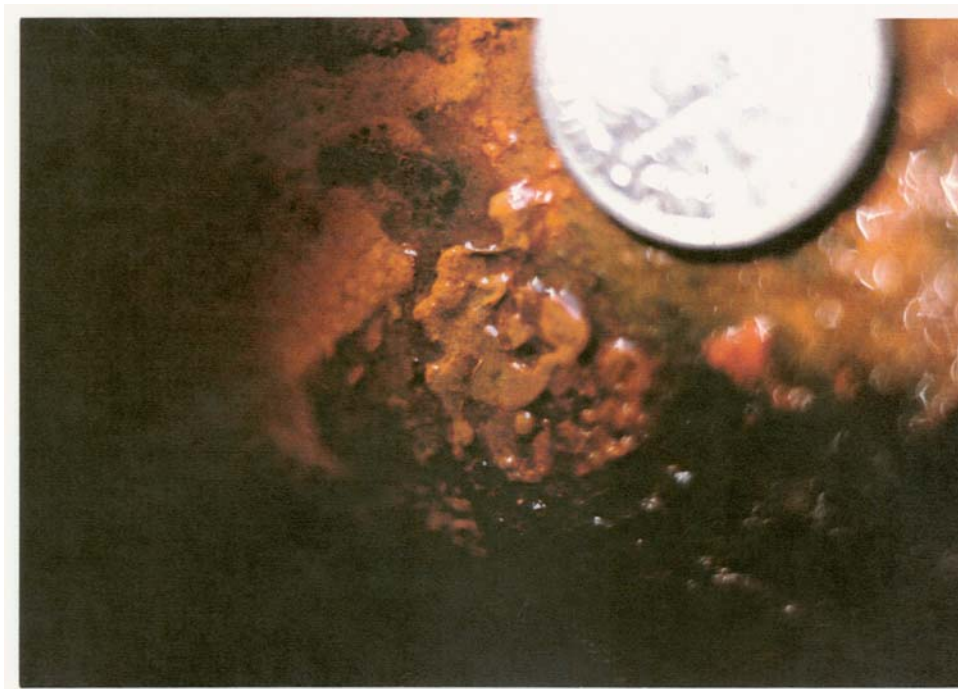
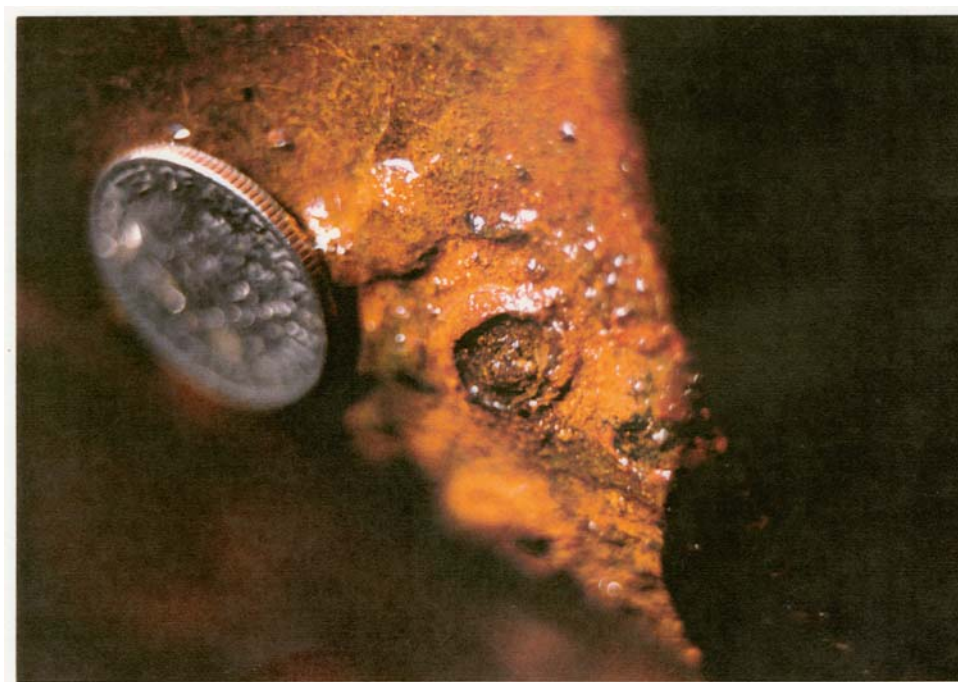
Station 976+40. Nodules of iron oxide characteristic of corrosion caused by anaerobic sulfate reducing bacteria at waterline on exposed steel of epoxy pipe. Water level recently lowered by removal of beaver dam. Inlet end. 1994

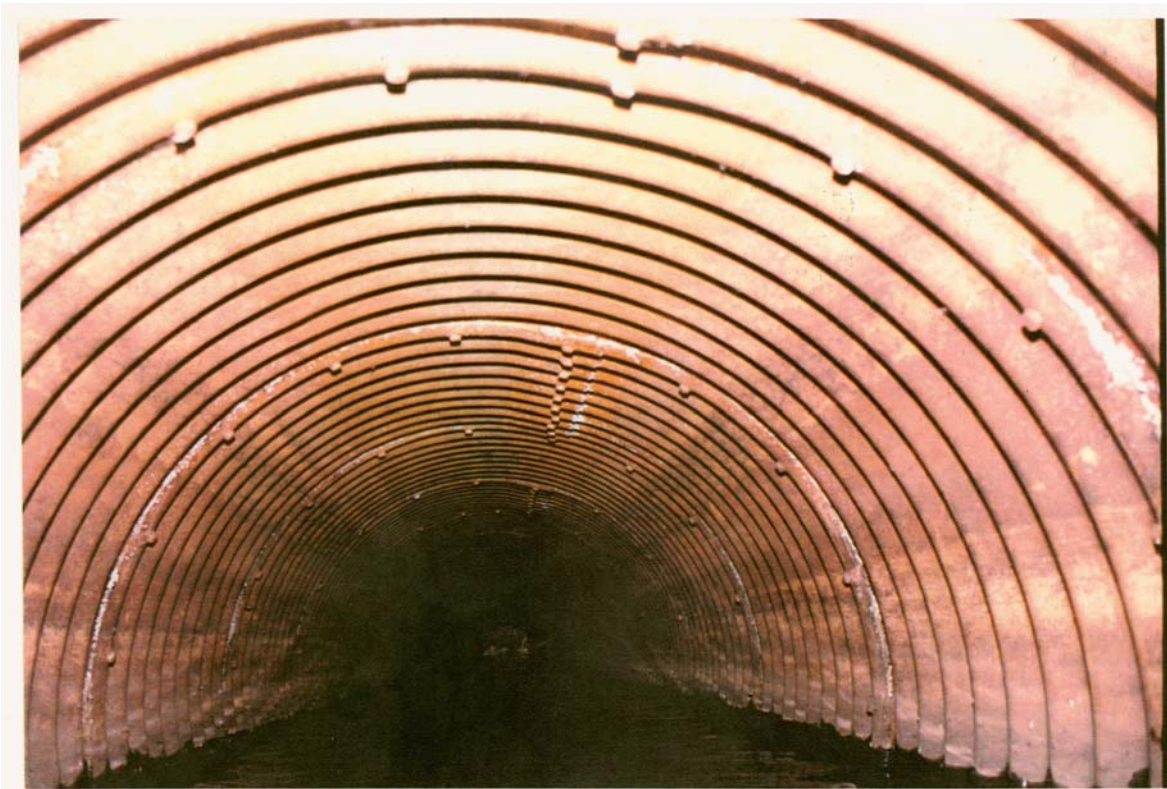
Station 976+40. Oxidation product at joints in aluminum pipe. 1994

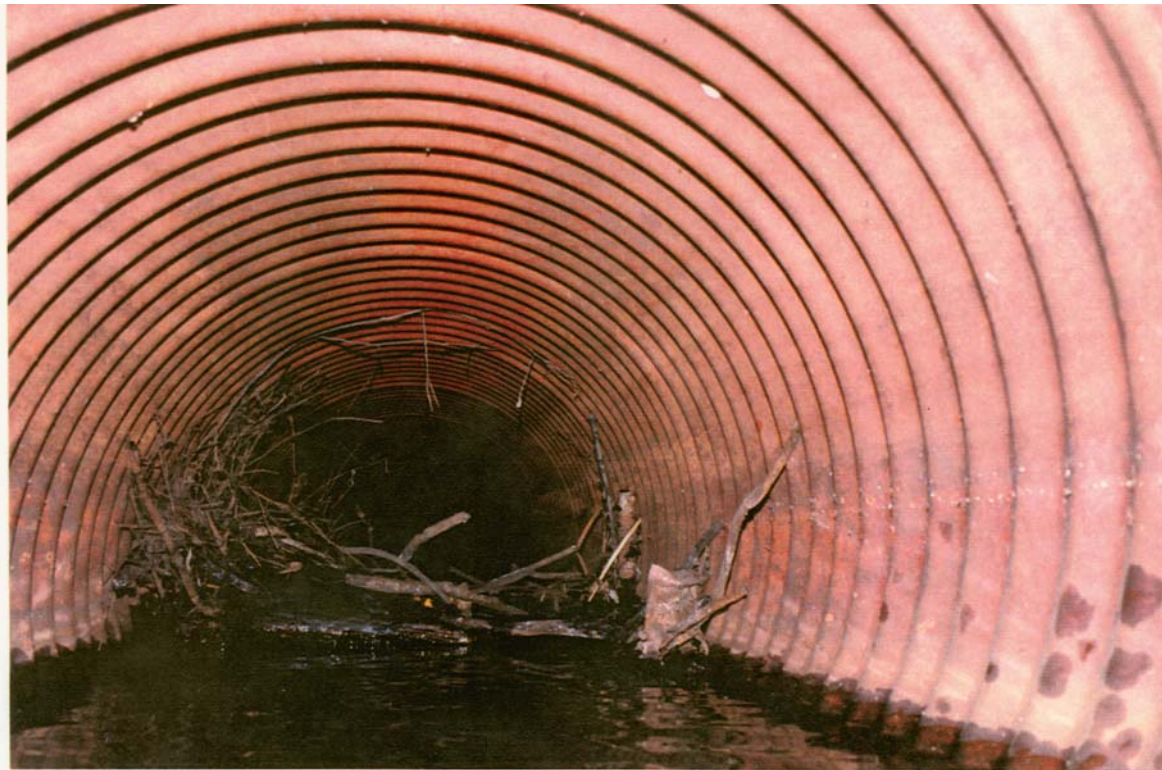
Station 976+40. Beaver dam in epoxy bonded pipe. 1994

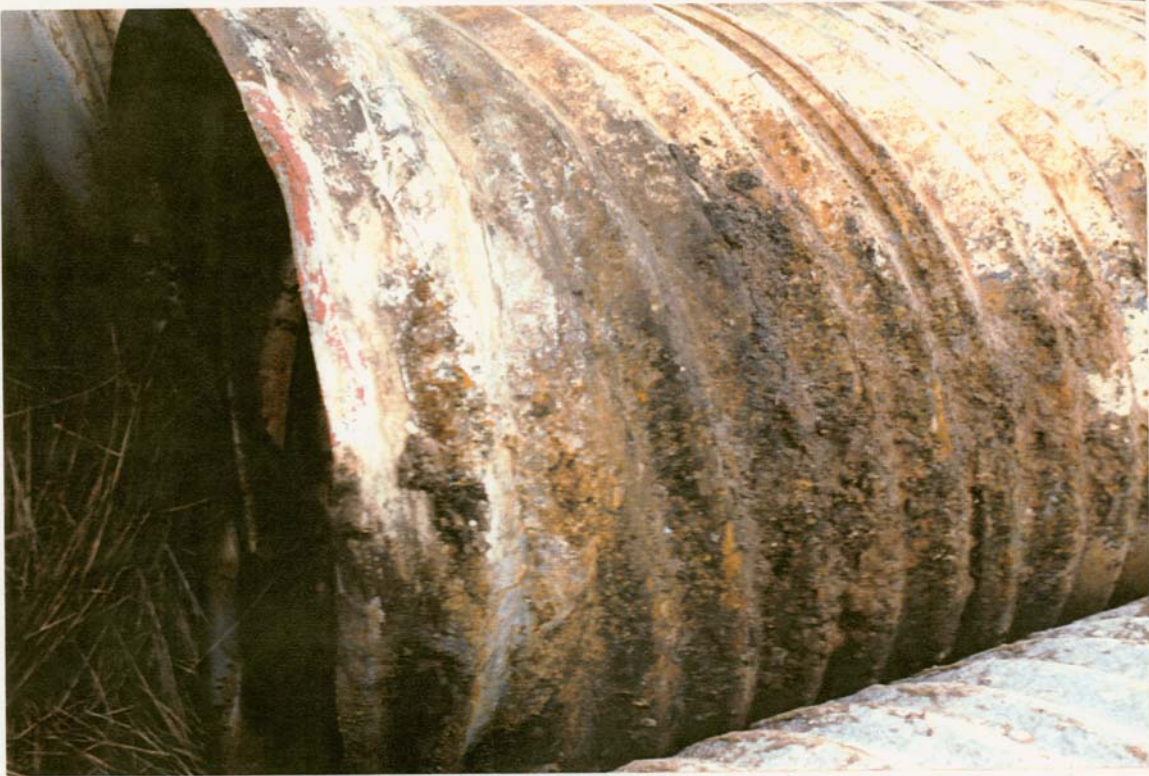
Station 976+40. Aluminized steel pipe. Organic-rich soil adhering to pipe. Pipes removed. 1995

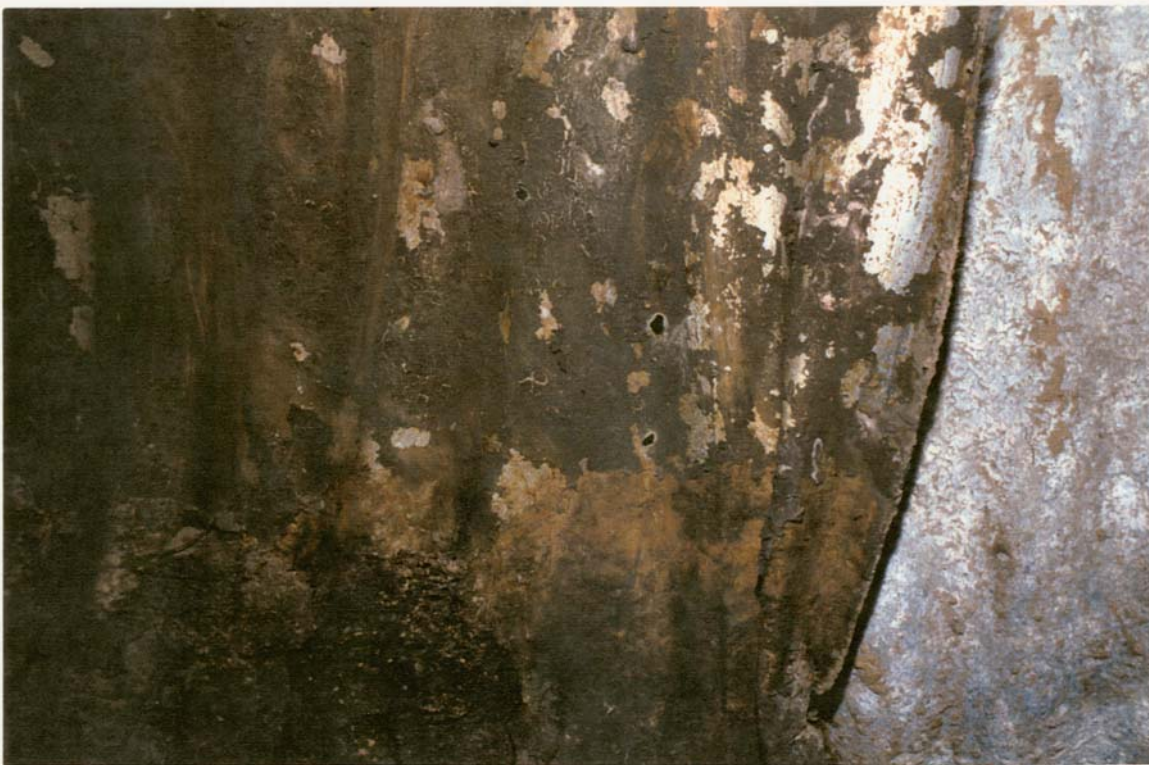
Station 976+40. Inside of same section of pipe showing several perforations.

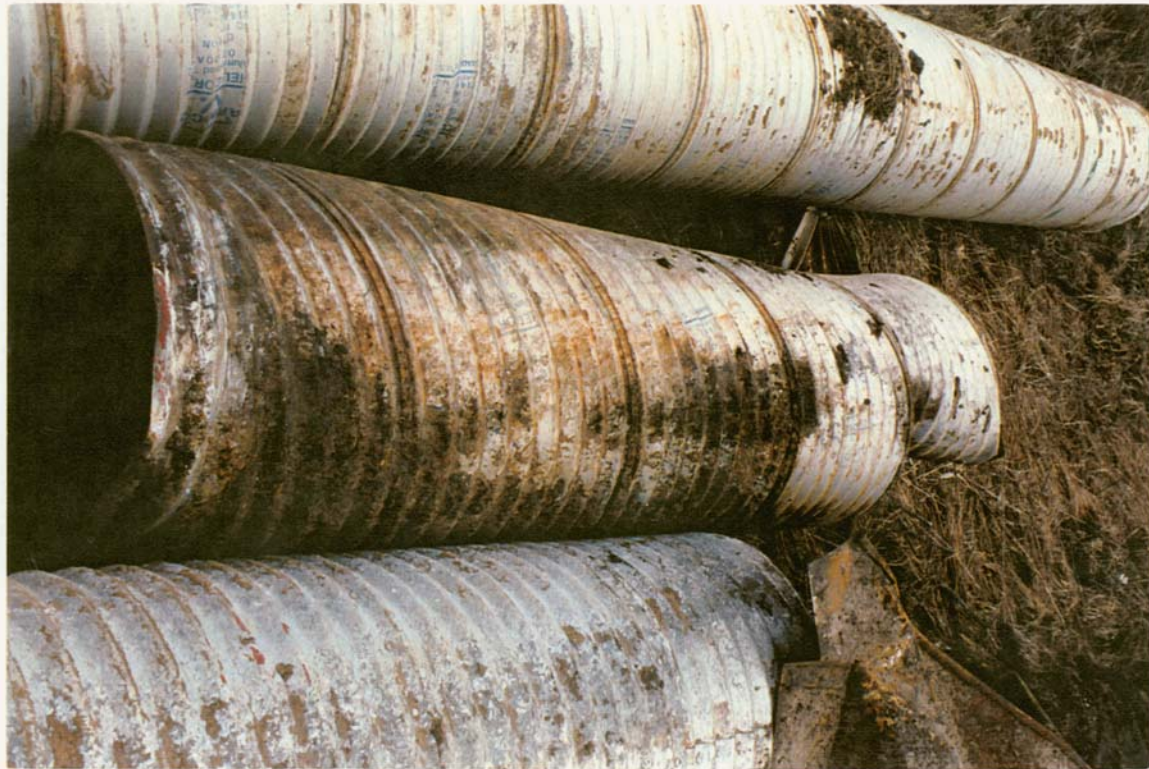
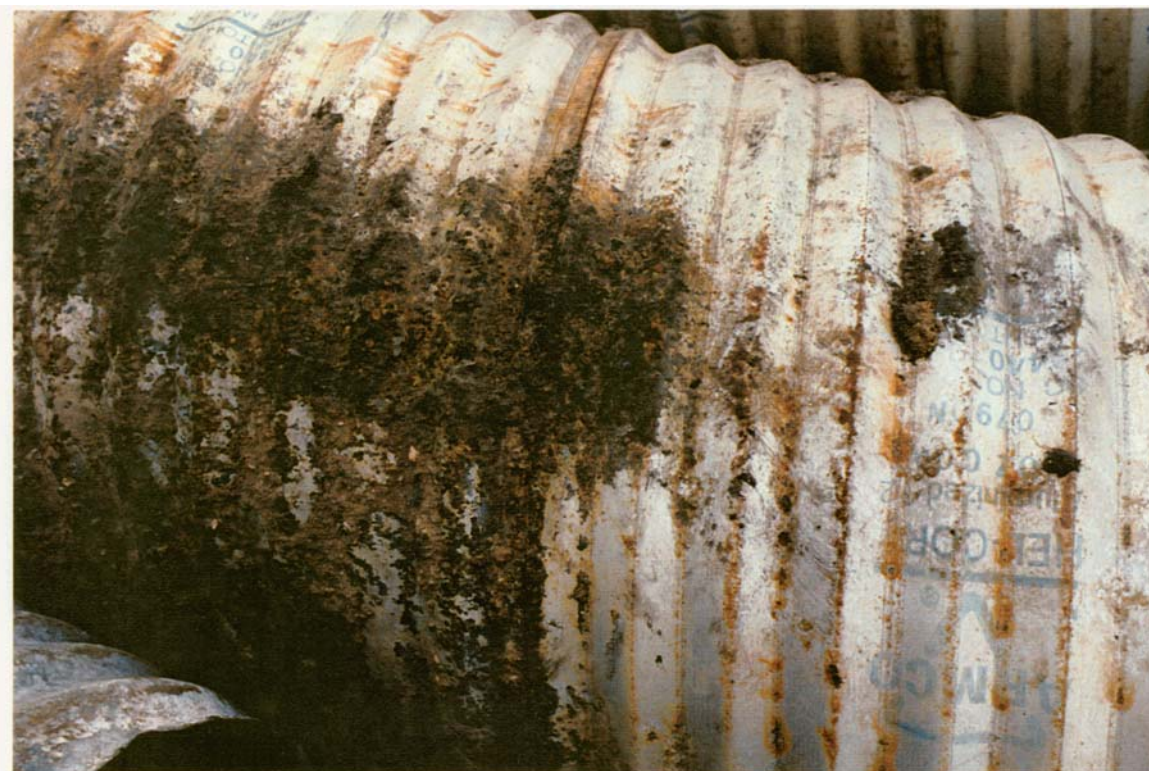
Station 976+40. Several small perforations in aluminized steel pipe associated with soil side corrosion in localities of organic rich sediment. This section of pipe disappeared between the culvert site and the county shop. 1995
